SAN FERNANDO, CALIFORNIA,
EARTHQUAKE OF
9 FEBRUARY 1971

GORDON B. OAKESHOTT, *Editor*
CALIFORNIA DIVISION OF MINES AND GEOLOGY

BULLETIN 196
California Division of Mines and Geology
Resources Building, Sacramento, California

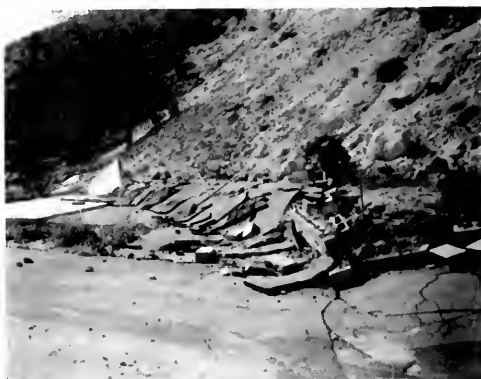
A few feet west of this cut, the California Division of Mines and Geology excavated a 17.7 m (58 foot) trench across the 70 cm (2.3 foot) high earthquake scarp to expose the geology (T8: California Division of Mines and Geology, this Bulletin, photo 5). This trench exposed a section similar to the artificial exposure in the Blue Star Trailer Park. A detailed sketch of the western wall of the trench and a locality map of the area are given in the pocket (plate 4). It was possible to investigate the geology in great detail because the moist, weakly to moderately cemented units were easily cleaned and trimmed on the walls of the trench.

Photo 5. Deformed asphalt pavement and uplifted concrete slab along the 70 cm (2.3-foot) high scarp of the Tujunga fault segment in the Blue Star Trailer Park. Trench 8 (plate 4) was cut near shovel. Note also rockfall debris triggered by earthquake above scarp. Photo by James E. Kahle.

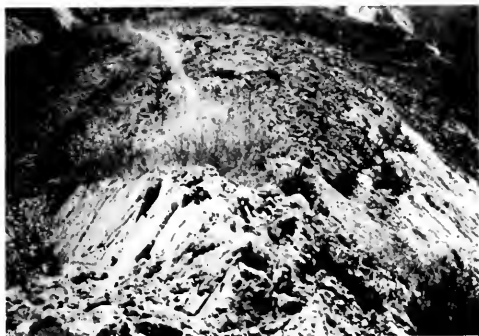
Photo 7. North-dipping bedding-plane fault in sandstones of Towsley/Pico Formation on ridge east of Indian Canyon (locality 98, plate 3). Scarp is 1 m (3.2 feet) high. This scarp is stratigraphically very close to the contact with the overlying Saugus Formation. Note shattered ground in background.

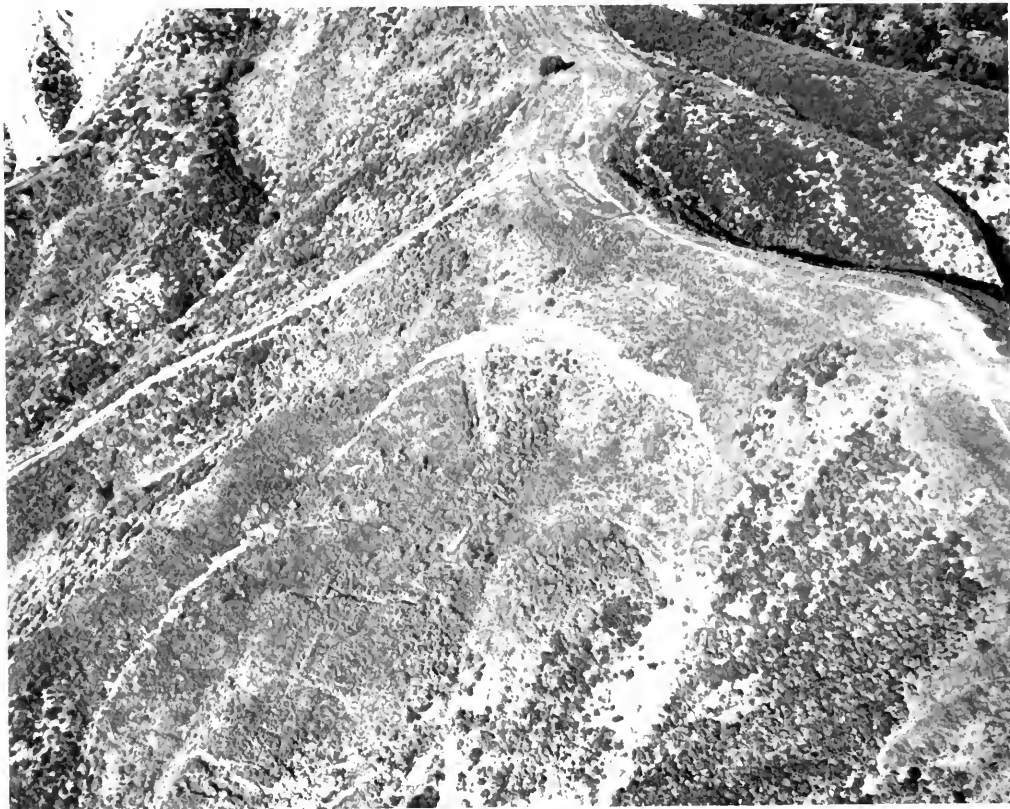
Photo 8. Large reactivated landslide on the eastern side of Bartholomew Canyon. Breakaway scarp is approximately 60 m (200 feet) across. Surface breaks along the Kagel fault trend upslope at the base of the rockfalls in the upper left corner of photo. Photo courtesy of the Los Angeles Department of Building and Safety.

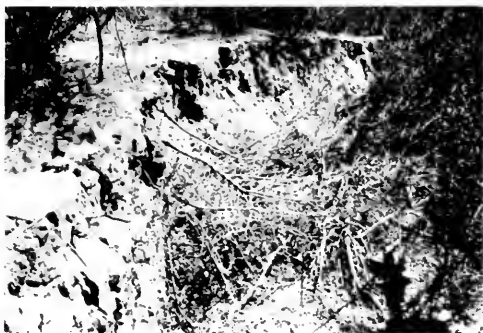
Photo 9. Fault scarp across top of ridge east of Dexter Park (locality 115, plate 3). Vertical displacement along the scarp ranges from 25 to 76 cm (9.8 to 30 inches) up on the north. No evidence of lateral displacement. Scarp is 90 m (300 feet) north of the trace of the Kagel fault. Pencil for scale on scarp in lower left of photo.

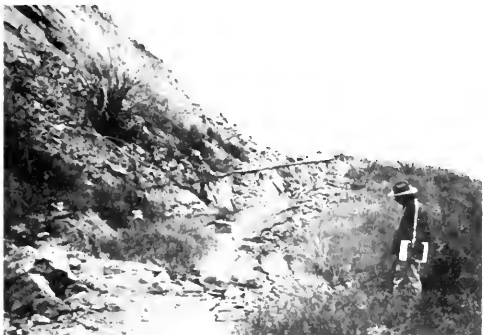
Photo 10. Earthquake-caused damage to a minor road on the east side of Indian Canyon 490 m (1600 feet) northeast of Oak Hill School. The landslide and rockfalls are both related to the failure of dip slopes in Towsley/Pico sandstone and conglomerate beds. Bedding planes are visible in the upper left portion of the photo.

Tertiary sediments (photo 10). An additional cause may be the proximity of these units to the zone of surface faulting and the probable greater ground motion to which they were subjected.

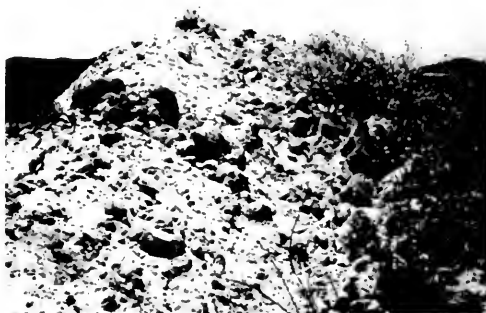
Photo 13. Intensively shattered apex of ridge in the Saugus Formation west of Marek Canyon (locality 110, plate 3). Note outwardly tilted blocks of soil 15 to 20 cm (6 to 8 inches) thick on right side of photo.

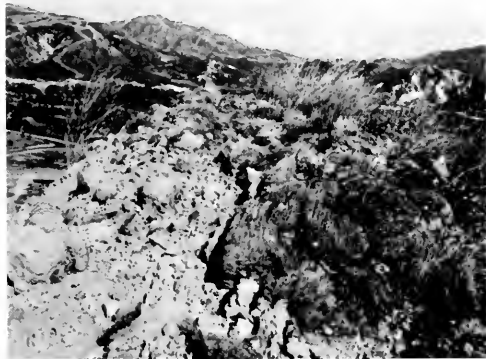
Shattering was well developed in areas of badland topography (109) and in areas characterized by the presence of numerous sharp peaks and ridge crests that are typical of terrain underlain by the Saugus Formation (112). Within areas subjected to the same intensity of shaking, only the tops of narrow ridges were shattered. This suggests that the cohesiveness of the soil was overcome at these localities by magnification of the energy relative to the surface area due to the focusing effect of converging planes or surfaces. Less well-indurated materials lying on more consolidated rocks also were shattered in less angular but topographically high places (photo 14). The shattering of terrace deposits on Sugarloaf (108) is an example of this type.

Photo 14. Shattered ridge top on the eastern end of Sugarloaf (locality 108, plate 3) west of Kagel Canyon. Material disrupted here is an old terrace deposit that caps this peak in the Saugus Formation. Note the jumbled blocks of sod, some of which are upside down. Photo by James E. Kahle.

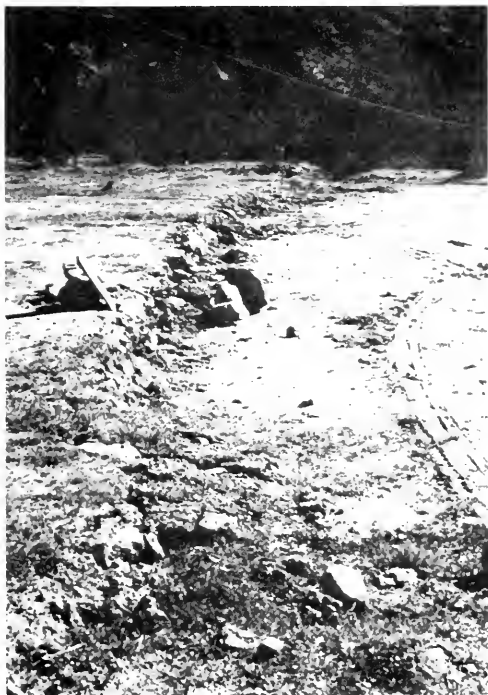
Surface faulting has different aspects where the surficial materials change along the trace of the Veterans fault. A well-defined 15-to-20 cm (6-to-8 inch) high scarp (photo 15) could be followed about 300 m (1000 feet) across graded bedrock surfaces from Wallaby Avenue to Graber Avenue. The scarp

Photo 15. Veterans fault scarp where it was best developed east of the corner of Tucker Avenue and Rejah Street. Scarp is 15 cm (6 inches) high across a graded bedrock surface. Pencil leaning on scarp for scale.

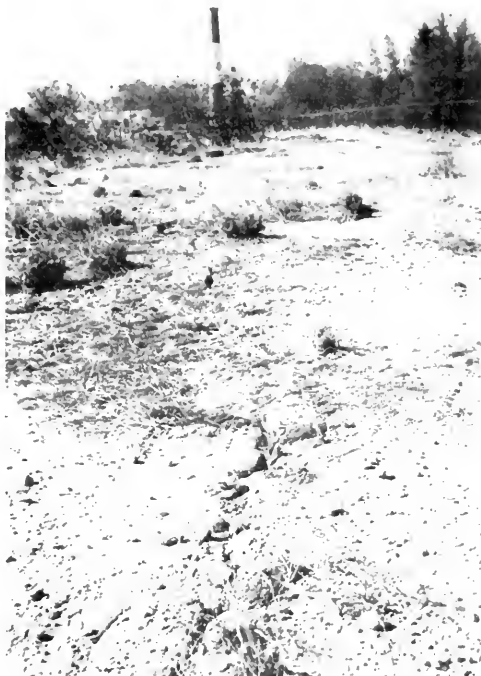
Photo 16. Western end of surface breakage across surface of old alluvial fan deposits approximately 400 m (1300 feet) east of the collapsed main buildings at the Veterans Administration Hospital. The scarp is 1 to 5 cm (0.4 to 2 inches) up on the north. This surface fault may be related to movements on the buried possible western extension of the Veterans fault. Photo by F. Harald Weber, Jr.

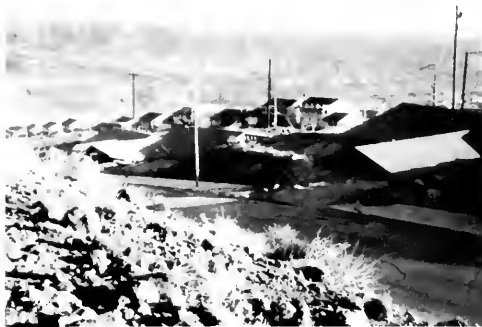
Photo 17. Shattered terrace deposits north of Walloby Avenue and about 122 m (400 feet) north of the Veterans fault (locality 48, plate 3). In the foreground, the roofs of houses under construction fell toward the north during the earthquake. Photo by F. Harold Weber, Jr.

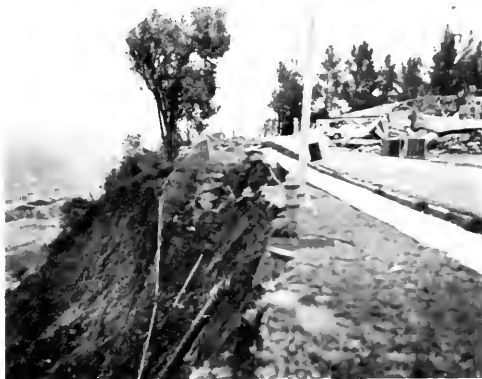
Slope failures are much more common than shattering in this area. The typical failure is characterized by the downslope movement of soil predominantly on the north sides of east-west-trending ridges. This effect is especially common on the north slopes of ridges in the Pacoima Formation east of Olive View Hospital (plate 3). One uncommonly large landslide did occur west of Loop Canyon (plate 3). The edge breakage in old alluvial fan deposits northeast of the Veterans Administration Hospital is a typical example of bank failure (photo 18).

Photo 18. Edge breakage and northeast-facing slope failure in old alluvial fan deposits of the Veterans Administration Hospital site. Photo by James E. Kahle.

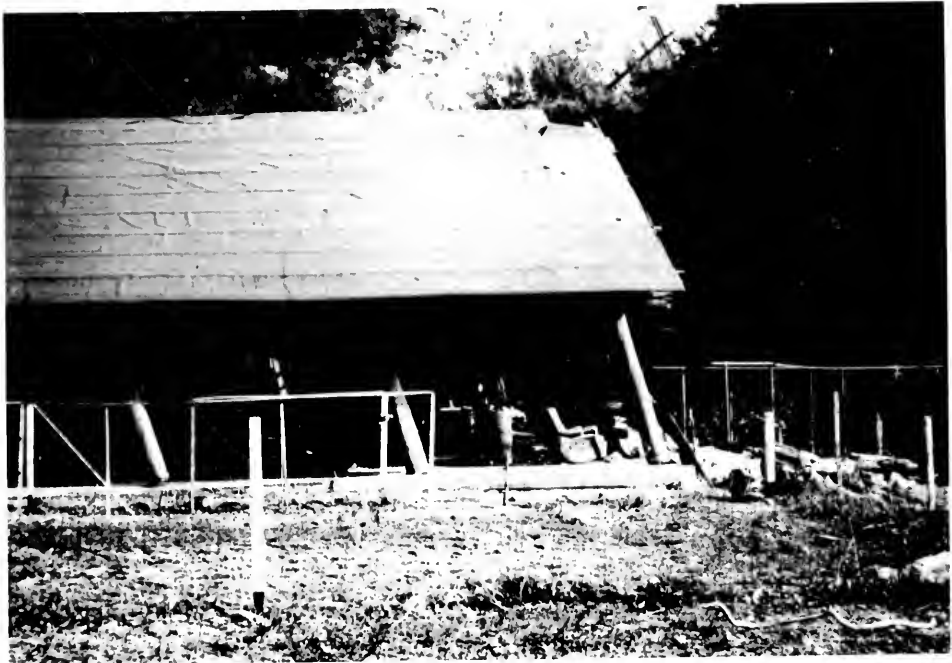
Photo 19. View east at a log lodge north of Wilson Canyon flood control dam and 670 m (2200 feet) north of the main building at Olive View Hospital. The inertial effect of severe ground motion on the roof has offset the roof N. 24° E.

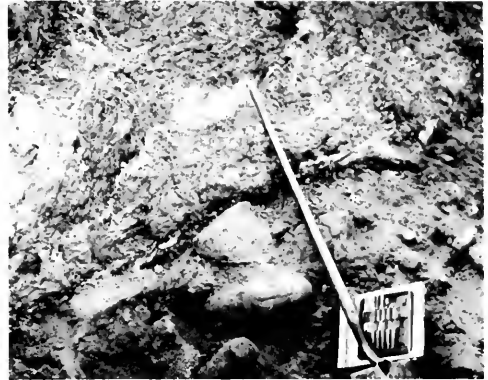
Photo 1. Fault scarp in gully west of Little Tujunga Canyon showing shale of the Modelo Formation in fault contact over alluvial cobble gravel. Locality (116), plate 3.

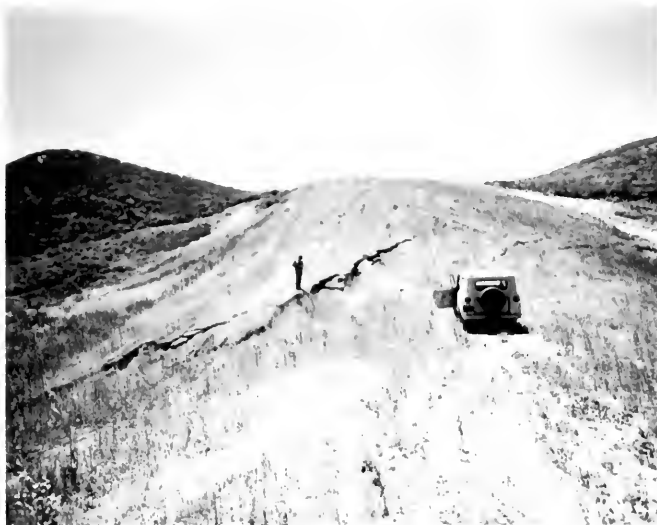
In the prominent saddle (123) north of the large hill between Little Tujunga Canyon and Cassara Canyon near the contact of the Modelo Formation and the Towsley/Pico Formation, large en echelon breaks trending northeast suggest a left-oblique-normal to normal sense of movement with the northwest side down (photo 2). Some ambiguity exists here between measured slip direction and calculated slip direction which ranges from approximately S. 88° W. to N. 45° W. These slip directions diverge toward both ends of the breaks. These faults cut bedrock of diverse textures as well as soil. They cross the ridge at an acute angle with the downslope side up on the east side of the ridge and the downslope side down on the west side of the ridge. They are nearly normal to bedding and appear to have a large lateral component of movement, all of which suggests a tectonic origin. A large extensional component of movement, the limited linear extent of the cracks, and their location near the heads of two large pre-existing landslides suggest a landslide origin. The writer favors the tectonic rather than landslide alternative, recognizing that a significant interrelationship between the two probably exists. Similar conditions may have influenced the formation of the other large landslides present along the contact between the Modelo Formation and the Towsley/Pico Formation.

Photo 2. View south toward large en echelon surface breaks across saddle and fire break northwest of Cassara Canyon. Left-oblique normal faulting is suggested. Locality (123), plate 3.

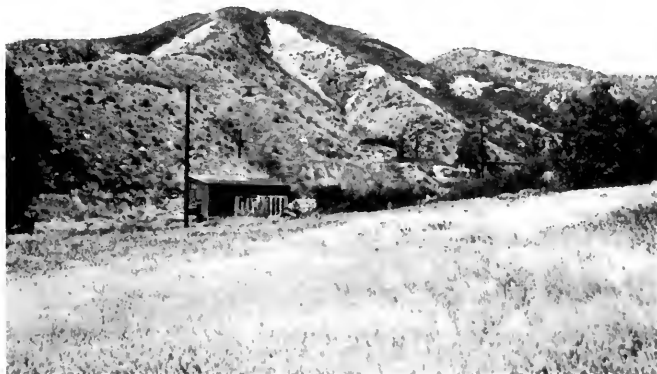
Along the hillside west of Oliver Canyon, the fault is well exposed by small slides (130) (photo 3), and a continuous trace is visible. A scarp with a 153-cm (5-foot) vertical component of displacement can be mea-

Photo 3. Lakeview fault trace along hillside west of Oliver Canyon marked by small slides. White layer in largest slide is fault breccia. Note boulder gravel of "thrust sequence" at base of hill and extending on up the canyon.

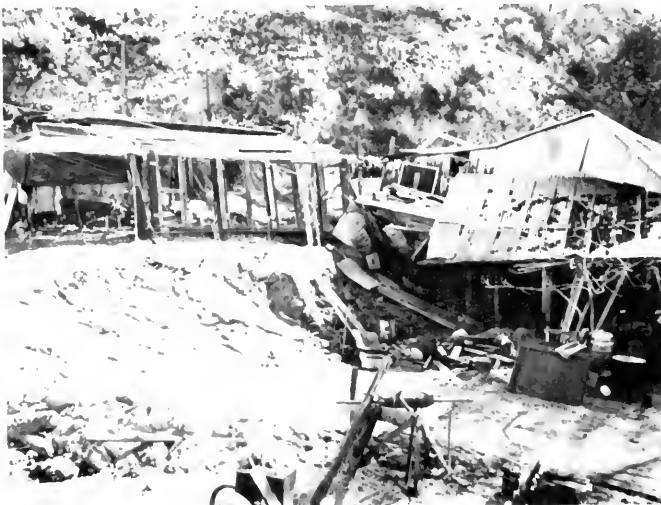
sured where the fault crosses the alluvium of the canyon. The road in the canyon bottom was displaced, and a barn on the scarp was badly damaged (photo 4). The fault dips about 30° N. here; and its contact with fluvial gravel, dipping about 10° N., is visible in a slide on the west side of the canyon.

Photo 4. Fault scarp and damaged barn in Oliver Canyon. The bird pens to the left were nearly level with the floor of the barn before the earthquake.

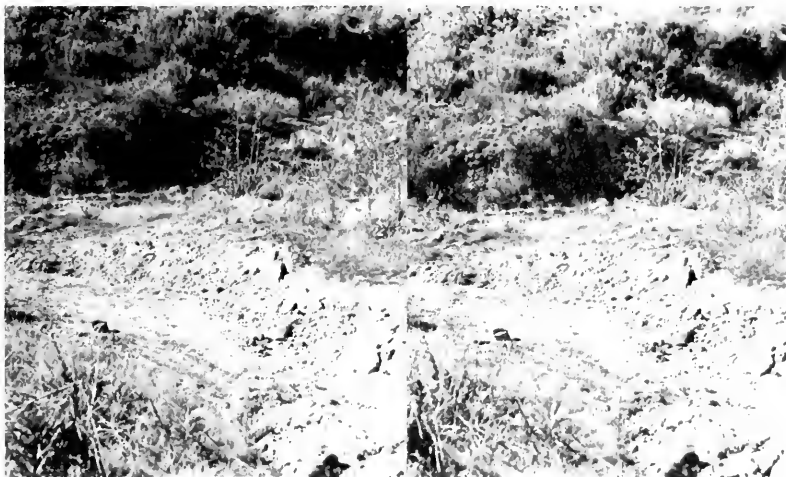
Schwartz Canyon to Lakeview Terrace Sanitarium. The fault trace in the alluvium of Schwartz Canyon is distinct and has a vertical component of about 30 cm (1 foot), and the scarp is typically expressed as a mole track (photo 5). Along the east side of Schwartz

Photo 5. Fault scarp in the alluvium of Schwartz Canyon. Stereoscopic view west; note hot for scale.

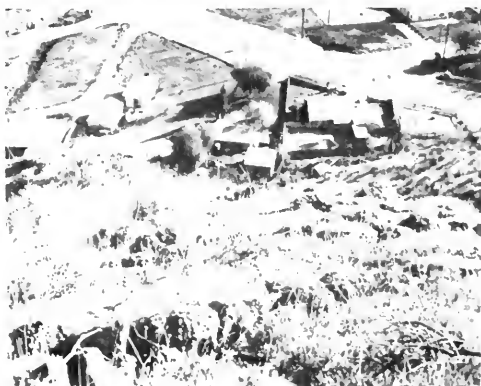
The soil is severely cracked on the slopes above, in between, and below the main and lesser traces of the thrusting. Patches of shattered soil are abundant, and some of the cracks have a "tipped-outward" sense of movement on them (photo 6). The soil cover appears to have been shaken so severely that, instead of slumping on the hillside as would be expected of loose material and rotating so that the slope of the original surface is less steep ("tipped-inward"), blocks of soil seem to have been flung outward from the hillside and to have rotated so that the slope of the original surface became steeper ("tipped-outward"). This

Photo 6. Severely cracked soil showing "tipped-outward" rotation of blocks in the proximity of houses north of Foothill Boulevard, east of Schwartz Canyon.

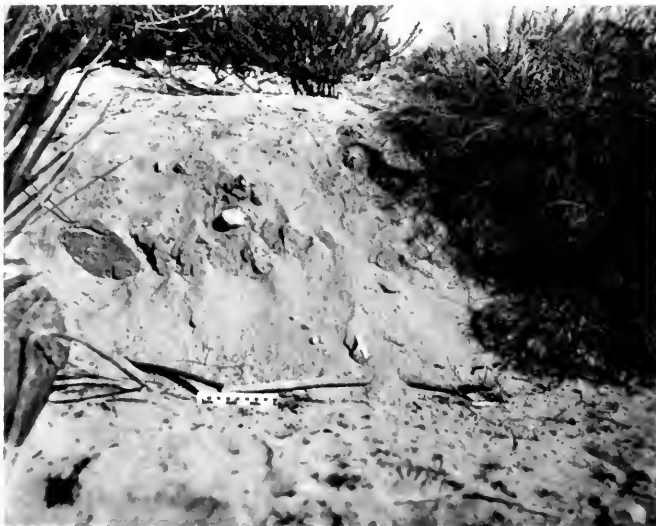
Photo 7. View north of fault scarp in soft sand of Tujunga Valley. Scale graduated in centimeters and inches. Locality (135), plate 3.

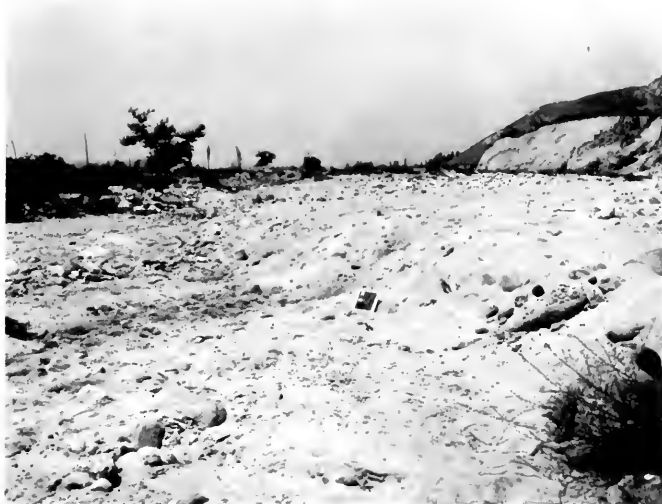
Photo 8. View west of fault scarp in sand and gravel of Tujunga Valley. Note landslides along cliff face in right background. Locality (136), plate 3.

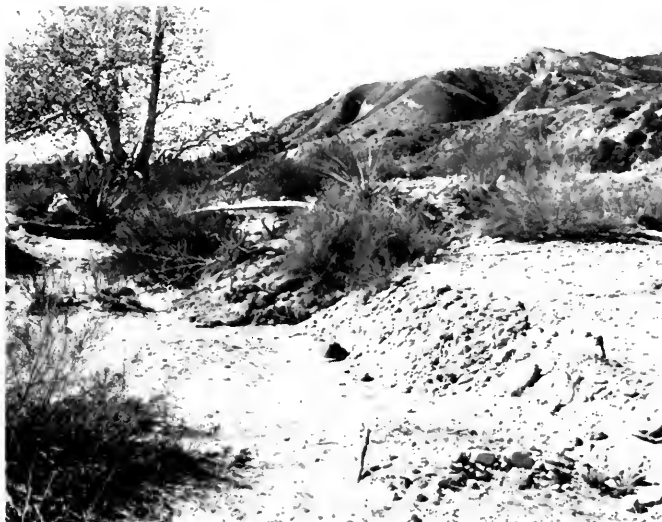
Photo 9. View west of fault scarp in the alluvium of Tujunga Valley. Note the limited width of broken soil, sand, and gravel. Not far scale. Locality (135), plate 3.

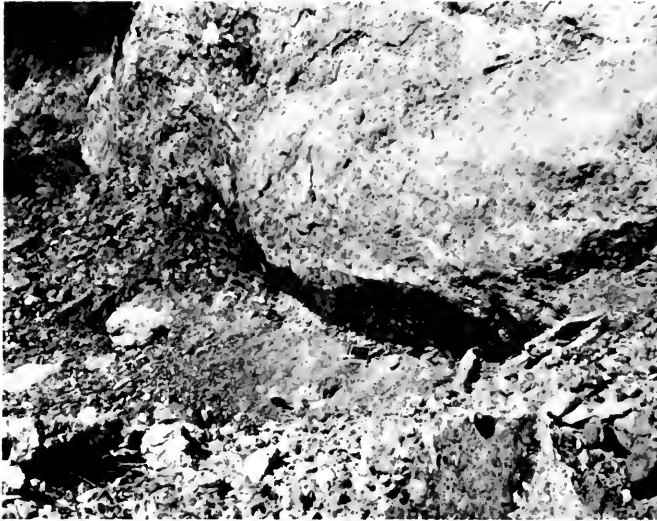
A slight rotation of the slickensides was visible (photo 11) (137), suggesting a left-lateral component of motion as the fault started to move but which rapidly changed to dip-slip movement. Three months after the earthquake, this evidence had been nearly obliterated by caving of the cliff face (photo 12) (137).

Photo 10. Fault scarp near the mouth of Ebey Canyon. Taken on March 2, 1971; clipboard for scale. Compare with photo 12. Locality (137), plate 3.

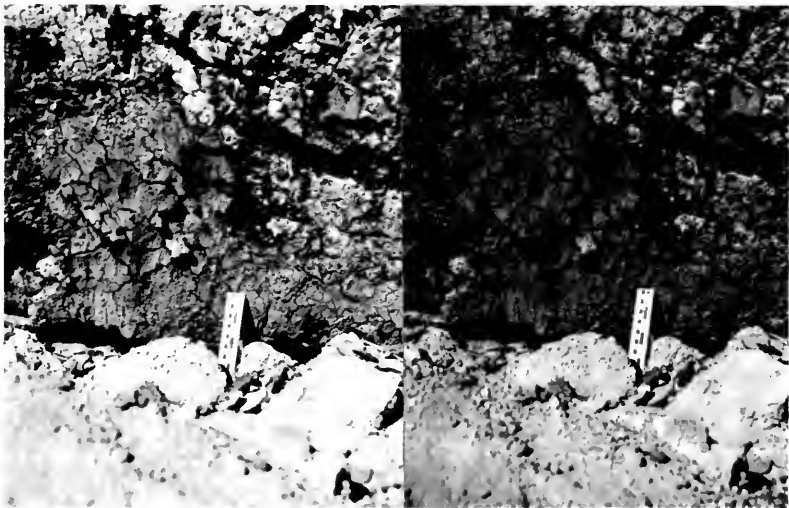
Photo 11. Detail of fault scarp near the mouth of Ebey Canyon. Stereoscopic view showing slickensides which coincide with the dip of the fault plane. Scale graduated in centimeters and inches. Locality (137), plate 3.

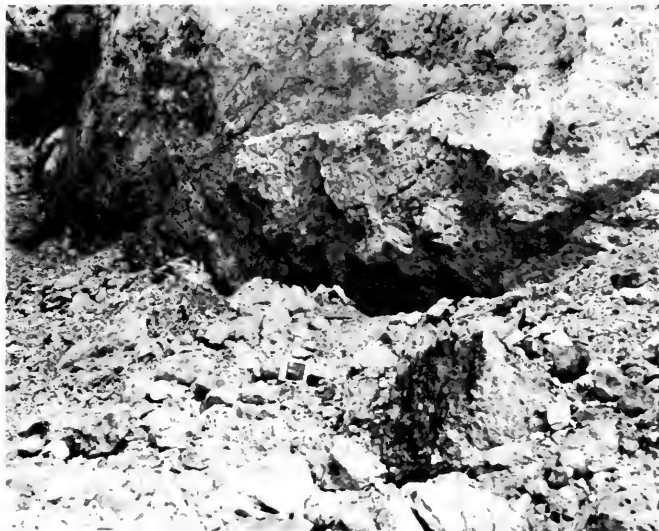
Photo 12. Fault scarp near the mouth of Ebey Canyon. Taken on May 9, 1971; clipboard for scale. Locality (137), plate 3.

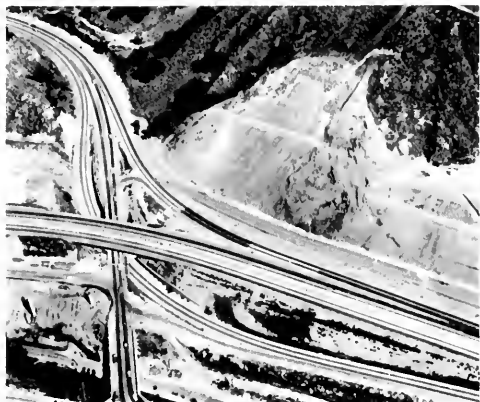
On the east side of the Golden State Freeway, just south of its intersection with the Sierra Highway, another mass of Towsley Formation failed through a 100-foot-high (30 m) cut of $1\frac{1}{2}$:1 ratio (photo 4). This failure was in water-laden, highly fractured siltstone and sandstone similar to the beds described above; however, there were significant differences between these failures. In this second slide, the cut slope was steeper and the rock mass was only roughly half as large in plan view; however, because of the arcuate nature of the slide plane, it had a greater average thickness. Possibly the cubic feet were nearly the same, but drilling would be needed to confirm this. The second slide mass lurched forward but did not come down slope more than several yards. This mass failed across the strike of beds which trend east-northeast and dip about 60° north, and the long axis of the mass trended west-southwest. The toe of the mass largely remained buttressed by pre-existing fill in a canyon adjacent to the south-southeast. The toe is only about 50 feet (15 m) from the freeway; in January 1972, this mass still posed a threat to traffic should it fail after heavy rains or during an earthquake.

Photo 4. Earthquake-triggered landslide in a steep cut at the intersection of Sierra Highway with Golden State Freeway, San Fernando Pass area. Weak, fine-grained, clastic beds in the Towsley Formation have failed across their strike. Part of the toe of the slide was buttressed by a previous fill in the canyon to the south. View is northeast. Photo courtesy of the Grading Section of the Los Angeles Department of Building and Safety.

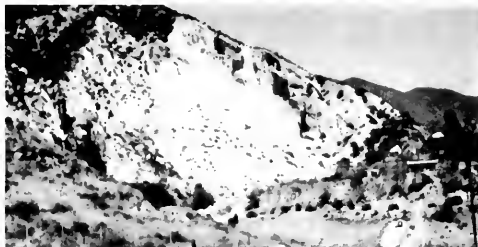
A large debris-fall occurred on the hill just west of the portal of the Los Angeles City Aqueduct. Here, a very steep, natural slope existed on fractured, west-trending, steeply dipping tan siltstone and sandstone of the Pico Formation. The water-saturated weak rocks could not withstand the strong shaking on the steep slope. Rocks broke into pieces a fraction of an inch to as much as several feet across and fell or rolled downslope (photo 5). Although this was the largest such failure observed in this area, other small debris falls and dry flows were very common along steep slopes, particularly along cuts on the Grapevine Canyon road and in the Magazine Canyon area.

Photo 5. Debris fall on steep slopes of the Pico Formation near the Los Angeles Aqueduct, San Fernando Pass area. View is east from the Golden State Freeway.

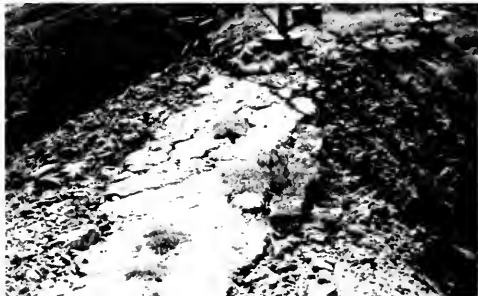
Department of Water and Power (3/1) and Southern California Edison Company. The towers are roughly 100 feet (30 m) apart on a narrow, steep northeast-trending ridge extending out from the main mountain mass. A northwest-trending and steeply dipping fault separates the ridge from the mountain mass, which is composed largely of pre-Cretaceous biotite schist and diorite gneiss. Thin beds of fractured siltstone, sandstone, and shale in the Towsley Formation strike northeast parallel to the long narrow ridge and dip about 80° to the northwest. The steeply inclined weak beds failed under the strong earthquake motion. Crack swarms and intensely broken zones were developed in the top few feet of weathered bedrock and soil. Cracks extend about 200 feet (60 m) along the ridge under both towers. Several footings and embankment supports for the towers were undermined or failed, but fortunately the towers did not fall (photo 6).

Photo 6. Shattered soil and weathered zone on steep, north-dipping beds of the Towsley Formation, San Fernando Pass area. View is southwest toward Southern California Edison Company transmission-line tower 3/1.

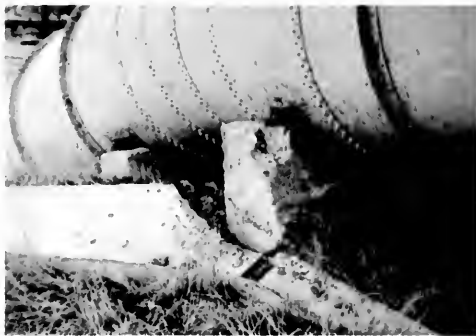
There was ground rupture about 600 feet (180 m) north of the Los Angeles City Aqueduct underpass of the Golden State Freeway. Rupturing took place on an elongate south-trending ridge at an elevation of about 1425 feet (430 m) in a location under the westernmost pipeline. This area is underlain by soil-covered siltstone of the Sunshine Ranch Member of the Saugus Formation. North-trending ground cracks and depressions were observed in a zone about 15 feet (5 m) wide and 40 feet (12 m) long. At the south, a west-trending rupture zone appeared to truncate the cracks and passed under the pipeline, rupturing the foundation and buckling a drain pipe in the

Photo 8. Part of the older Los Angeles Aqueduct pipeline just north of the Golden State Freeway where it rotated and slumped. A ground rupture in the Sunshine Ranch Member of the Saugus Formation passes beneath the broken foundation. View is south-southwest.

process (photo 8). Soil was heaved up near the intersection. This feature plus the buckled drain implied compression and possible faulting. No bedrock was observed; there was a grass cover on the soil, so no definitive information was obtained about the rupture. As a result of ground deformation, the foundations for the pipeline were tilted down on the east and rotated to the south several inches for a distance of about 150 feet (50 m).

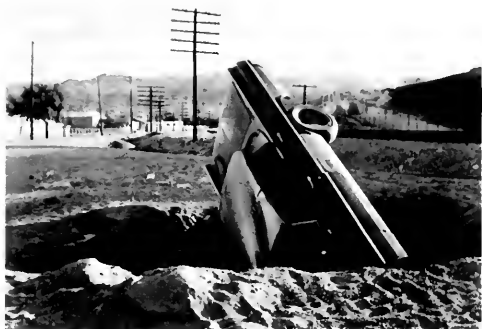
Several Southern California Gas Company gas mains in Newhall cracked or were broken. One main caught on fire and burned until mid-morning of February 9 before being extinguished. Another main exploded during the first strong motion, creating an 8-foot-deep (2.5 m) crater. A motorist was driving by at just that moment; his car slid slowly into the crater as the walls began to slip back into the center

Photo 9. An 8-foot-deep crater created when a gas main blew up on Pine Avenue just south of San Fernando Road, Newhall. Main blew during first strong motion from the earthquake but fortunately did not catch fire. The car slipped into the crater as the walls began to slide back into the center. Photo courtesy of the NEWHALL SIGNAL.

after the initial explosion (photo 9). Fortunately the main did not catch fire; and the motorist escaped unhurt.

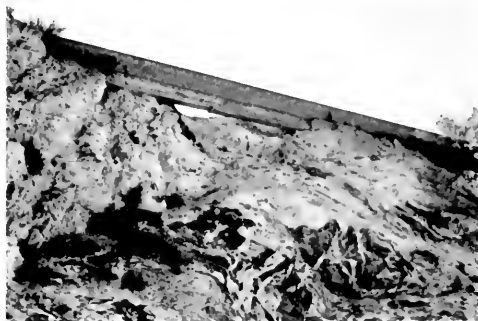
Photo 10. Scars left by debris fall from steep cut on fractured anorthosite. Area is on Soledad Canyon Road about 1 mile east of Soledad Campground. Block wall was completely reinforced with steel and did not fail even though undermined.

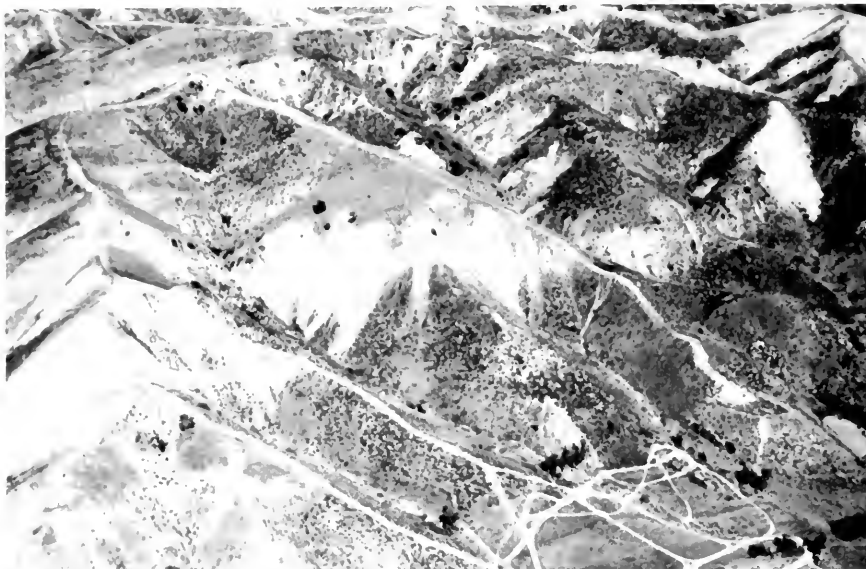
Photo 2. Landslides localized along individual beds within the Towsley-Pico Formations (undifferentiated) and the Madelo Formation east of Lopez Canyon.

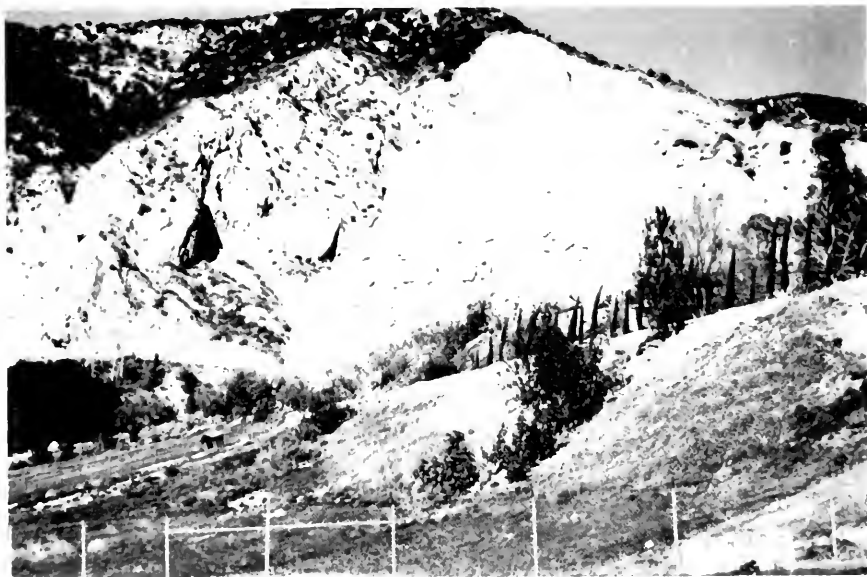
Photo 3. Landslide in oversteepened Pico Formation, south end of San Fernando Pass. Photo by James E. Kahle.

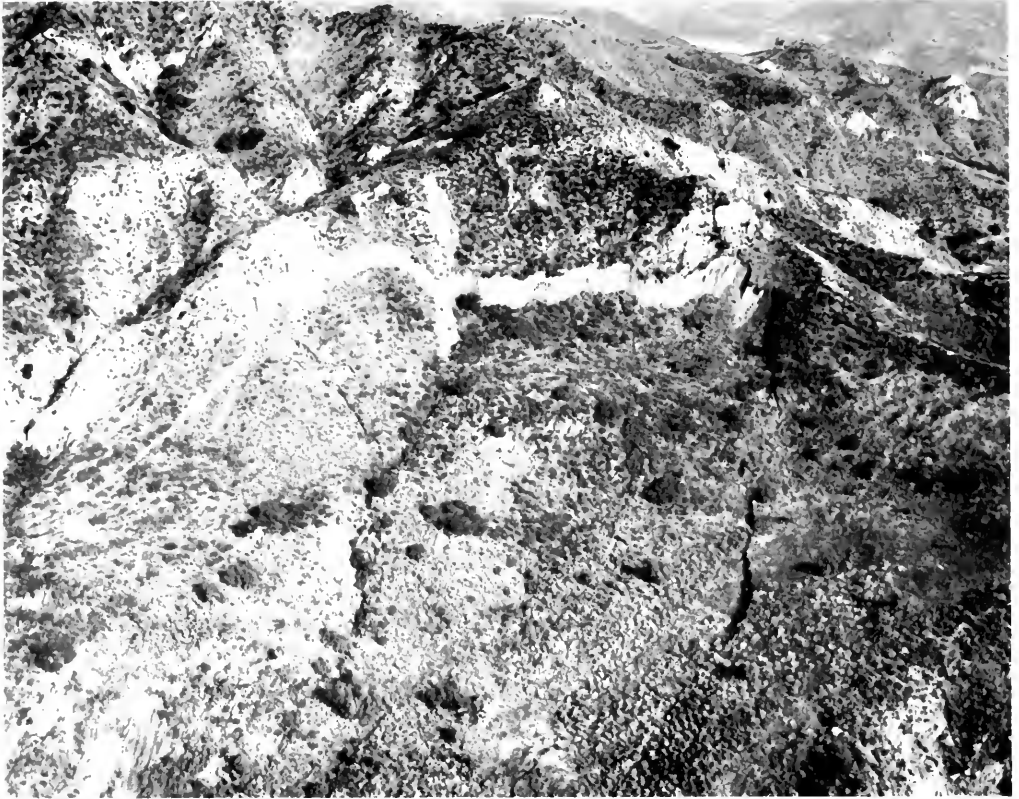
Photo 4. Renewed movement in pre-earthquake landslide in Modelo Formation east side of Schwartz Canyon. Photo courtesy of Los Angeles Department of Building and Safety.

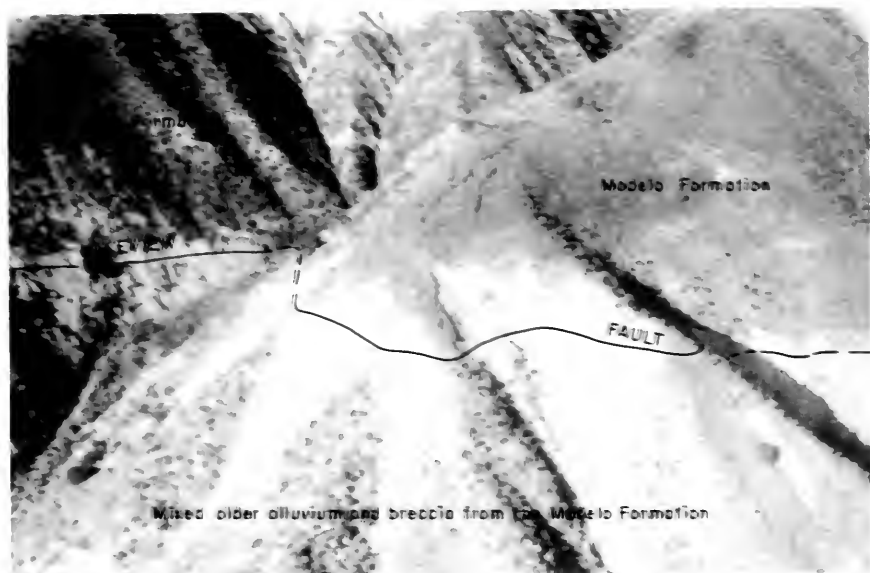
Photo 5. Landslides localized along the Lakeview fault just east of Schwarz Canyon. (Geology after J. E. Kahn, plate 2, this Bulletin.)

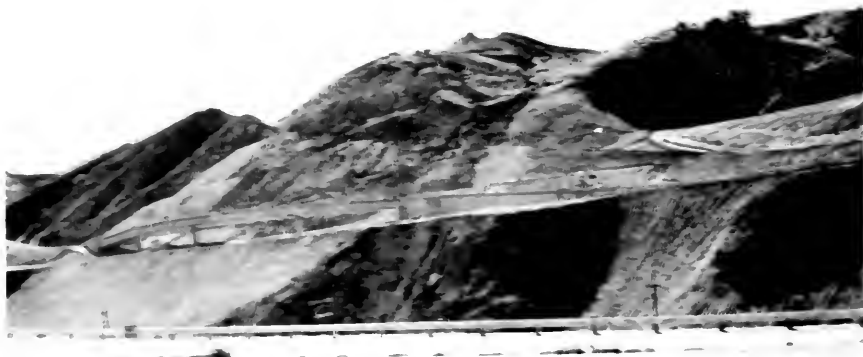
Photo 6. Landslide in outcrop adjacent to U.S. Highway 99 (Golden State Freeway), north side of San Fernando Valley. Photo by James E. Kahn.

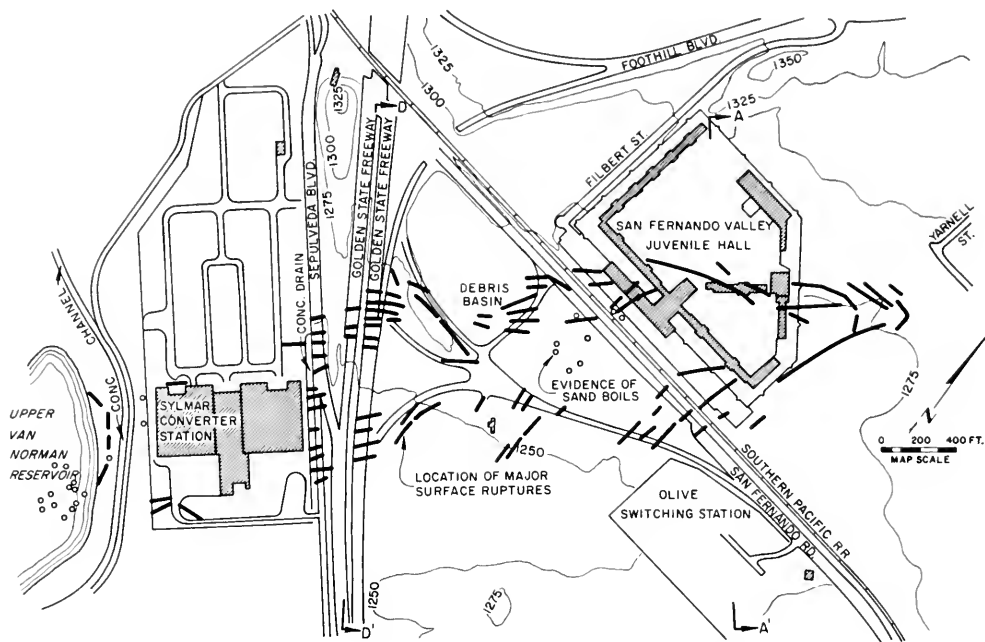
The limits of the zone of displacement are indicated by the pattern of ground-surface ruptures shown on figure 2. The zone is 4000 feet long with a maximum width of 900 feet. It extends from a point 500 feet northeast of the Juvenile Hall to within the Sylmar Converter Station site at the edge of Upper Van Norman Reservoir. The ground surface descends approximately 40 feet in elevation along the length of the zone, an average slope of about 1 percent. Movement within the zone was downslope in a southwest direction. The north boundary of the zone bisects the Juvenile Hall site and transects the southeastern third of the Converter Station site. Ground ruptures along this boundary indicate right-lateral slip, and the trend of major cracks is generally parallel to the direction of movement of the displaced zone. The south boundary of the zone crosses the southeast corner of the Juvenile Hall site and extends into the Converter Station site south of the main building. Ground ruptures along this boundary are characterized by left-lateral slip, and the larger cracks generally trend nearly north in an *en echelon* pattern, approximately 45 degrees to the direction of gross movement.

Figure 2. Location of ground surface ruptures in the zone of displacement.

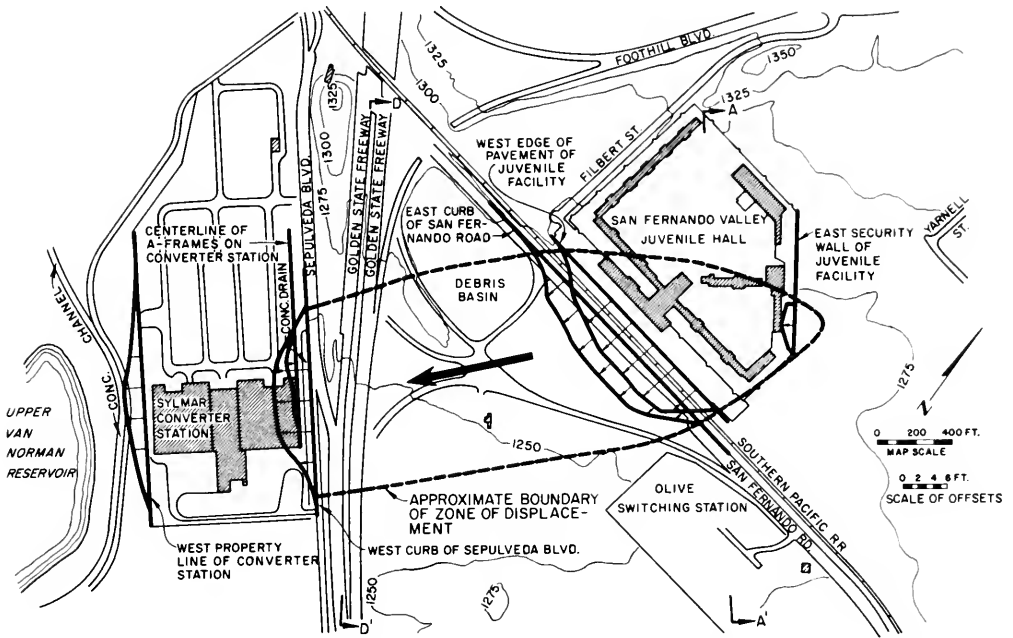
The amount of relative lateral movement within the displaced zone (figure 3) is based on measured offsets of curbs and property lines crossing the zone. These offsets indicate as much as 5 feet of relative lateral movement at the Juvenile Hall site. The same magnitude of relative movement occurred as far to the southwest as Sepulveda Boulevard, adjacent to the Converter Station. However, southwest of the drainage channel, which separates the Converter Station from Sepulveda Boulevard, the lateral movements measured were no greater than 2 feet.

Figure 3. Relative lateral ground movement in the zone of displacement.

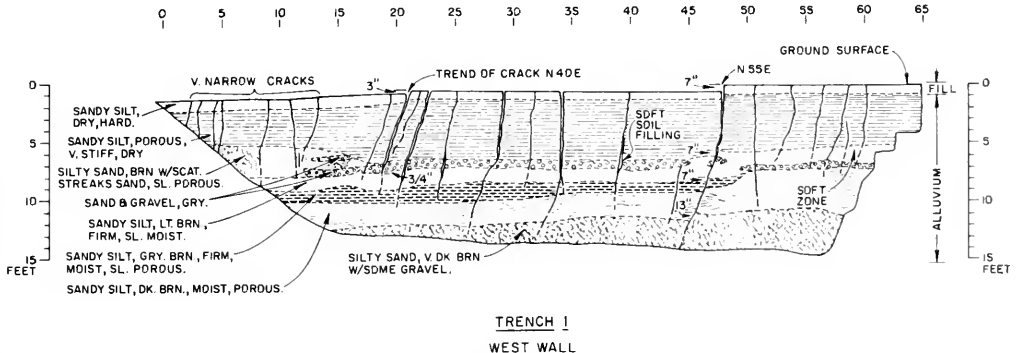
Fernando Road. In general, the cracks died out and curved inward with depth toward the interior of the zone of displacement. Figure 4 represents the conditions encountered in a trench trending nearly north across the north boundary of the zone on the Juvenile Hall site. The largest crack coincides with a 7-inch vertical displacement of the ground surface, and underlying soil contacts are similarly displaced. Near the bottom of the trench, however, the crack is coincident with a displaced soil-contact that has almost twice the amount of offset of higher strata. In view of the lateral continuity of the boundaries of the involved soil horizons, such a difference must represent evidence of prior displacement. Narrow vertical zones of soft soil, truncated at the top by alluvium and fill soil, were also found. Since vertical displacement is not apparent, these zones most probably represent loosely filled tension cracks produced by displacement prior to 1971.

Figure 4. Exploratory trench across ground ruptures on the Juvenile Hall site.

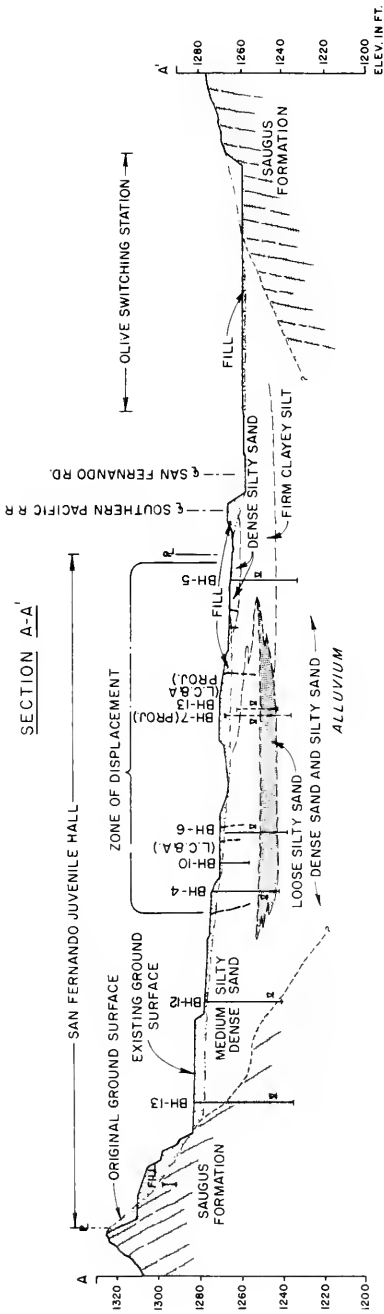
figure 6. This section is taken along a line transverse to the direction of movement within the zone of displacement. The sand and silt are typical of material near the termini of most merging alluvial fans. The significant feature, however, is the existence of a soft, saturated zone underlying the dense, dry upper zone. Alluvium in the soft zone consists of sandy silt and fine sand of a uniform texture. A similar profile was disclosed in a penetrometer survey by the California Division of Highways (C. E. Marek, written com-

Figure 6. Geologic and soil profile across the Juvenile Hall site.

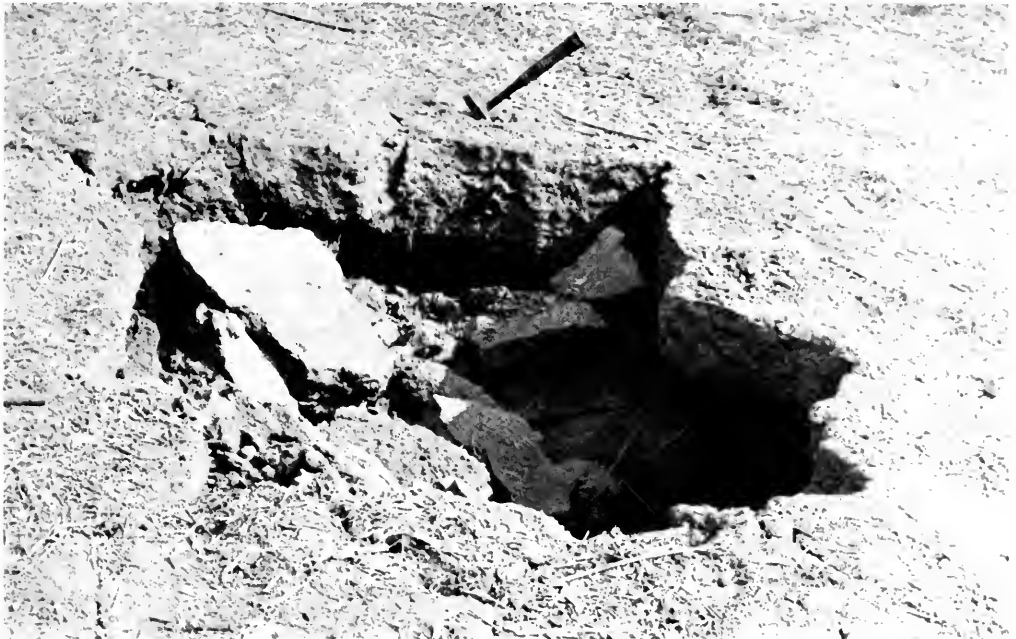
Photo 1. Crater resulting from consolidation of soft soil by a small dynamite blast during seismic refraction survey.

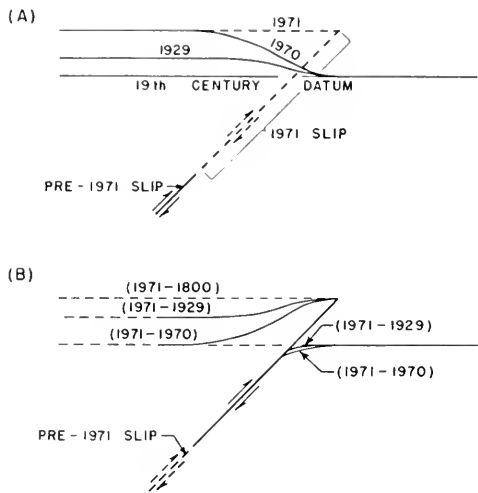
Figure 3. Qualitative elastic rebound model for the earthquake. Part A shows the progressive deformation and rupture of a hypothetical 19th century horizontal datum at sample times 1929, 1970, and post-earthquake 1971. The pre-earthquake deformation is associated with slip on the deepest sections of the fault (the solid fault line which extends to indeterminate depth in the figure). The sudden deformation at the time of the earthquake is associated with rupture of the hitherto locked section of the fault (dashed fault line in figure). Part B shows qualitative results of the comparisons of postearthquake leveling with elevations determined in 1929 and 1970.

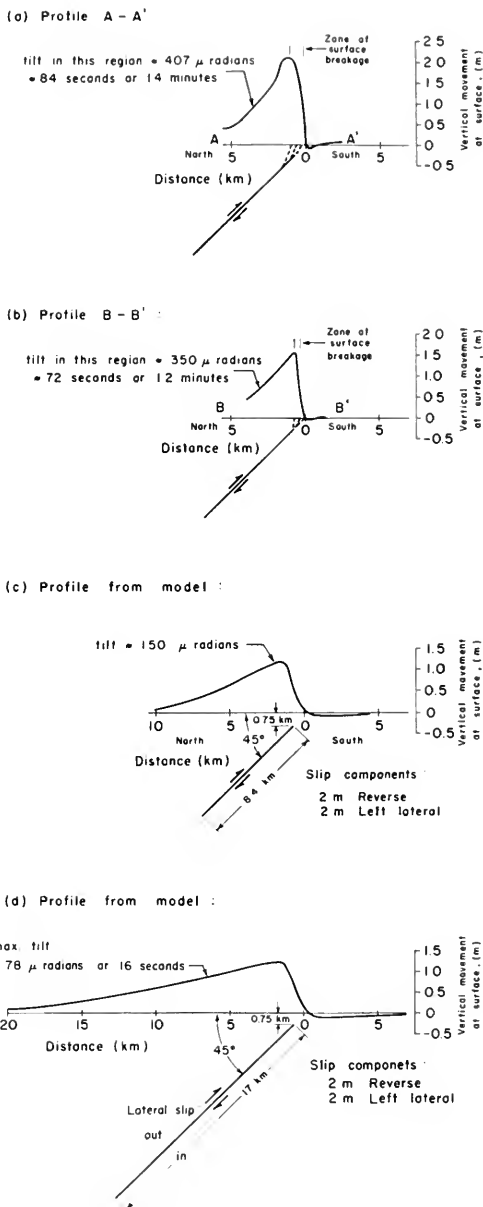
Figure 4. Profiles of observed and theoretical vertical displacements. Ports A and B show vertical displacements along lines A-A' and B-B' indicated in figure 2. Ports C and D show vertical displacements predicted by two dislocation models studied.

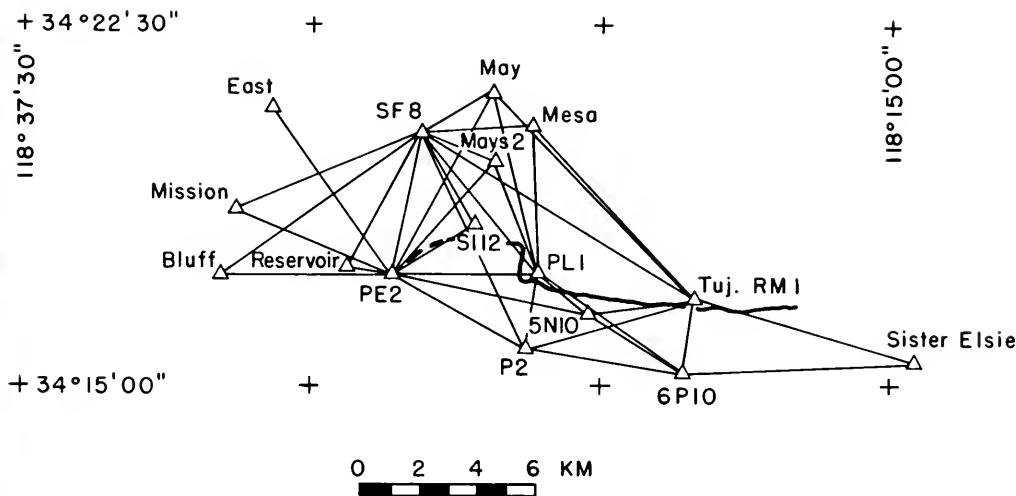
The zone of tectonic rupture, which presumably represents the fault trace, is also sketched in figure 5. Comparison of figure 5 and table 2 shows that lines which cross the zone of tectonic rupture at a high angle (for example, PL1 to P2, TUJ RM1 to 6P10, SF8 to P2) tend to be shortened by the earthquake, suggesting reverse faulting. Lines which cross the zone of tectonic rupture at low angles and trend NW (for example, 6P10 to PL1) tend to be lengthened, whereas similar lines which trend NE (for example, P2 to TUJ RM1) tend to shorten. These low-angle lines then suggest left-lateral slip on the fault. A more detailed discussion of the horizontal displacements will be given in the following section where comparison can be made with a theoretical model.

As can be seen in figure 5, the postearthquake surveys do not control the position of station EAST. We have used the postearthquake measurements of the National Geodetic Survey to calculate changes for two additional lines, EAST to MISSION (shortened .08m) and EAST to MAY (shortened .10m), which, together with the line PE2 to EAST, control that position.

Figure 5. Trilateration network observed in 1971 to study horizontal displacements. The lengths of the lines shown were all measured by Geodolite. The heavy sinuous line running from near PE2 past SI 12, PL1, and TUJ. RM1 represents the San Fernando fault zone shown in figure 1.

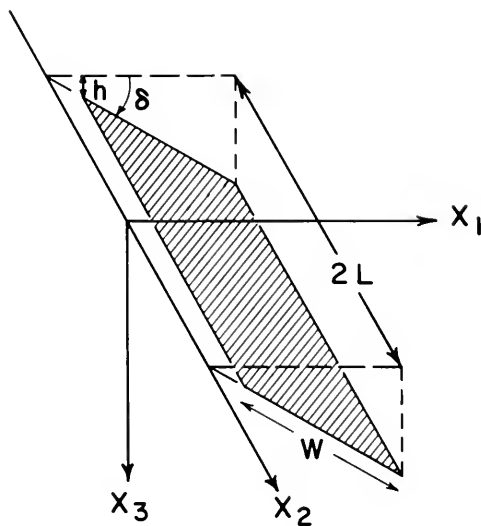
Figure 6 shows the parameters of fault dip (δ), fault length ($2L$), fault width (W), and depth to the top of the fault surface (h) needed to describe the fault model. In addition, the position of the origin of coordinates, the dip direction, and two components of slip (dip slip and strike slip) must be specified. Table 3 shows the parameters chosen for the dislocation model employed in this paper. The fault length has been chosen to match the length of the observed zone of surface rupture. The dip was suggested by the distribution of aftershocks. The other parameters were chosen to make the calculated surface deformation approximate the observed deformation. The position of

Figure 6. Parameters required to define a dislocation model of a fault. The shaded rectangle represents the fault surface (length $2L$, width W) which dips at angle δ in the x_1 direction. The top of the fault is buried a depth h below the free surface (x_1 - x_2 plane).
